Analysis of Pakistani Ghauri Missile Test of 28 November 2012

INTERNATIONAL STRATEGIC AND SECURITY STUDIES PROGRAMME
NATIONAL INSTITUTE OF ADVANCED STUDIES, BANGALORE, INDIA

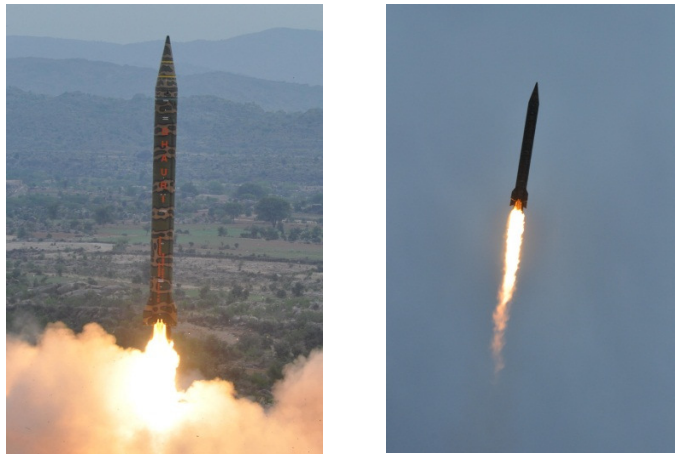
Figure 1: Ghauri flight of 28/11/2012

The two pictures indicate normal take off and normal flight. The flight seems to have developed problems at a later stage. This is based on the Pakistani media report that large fragments of the missile fell in and around the village of Dadu in Sind Province. The internet edition of the Dawn¹ quoting a military spokesman stated that *“the metallic objects found in a remote area of Dadu were part of the motor body which separated from the missile as planned and within the safety corridor”* (emphasis added)

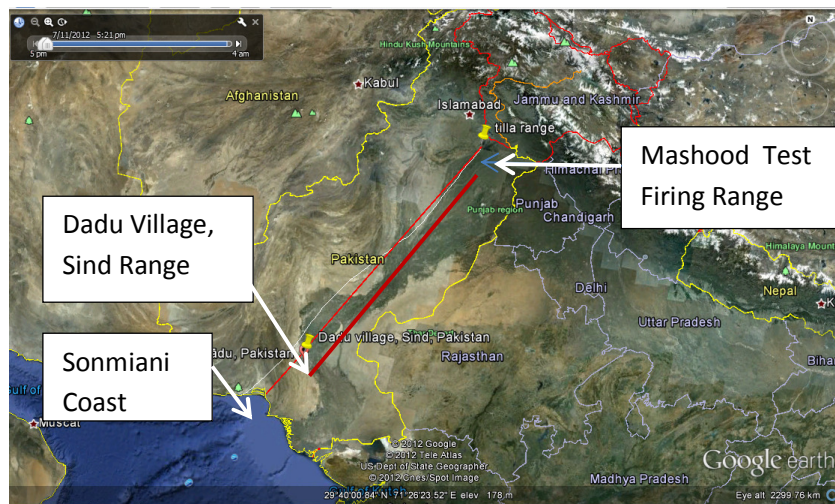
Figure 2: Ghauri missile ground trace

Dadu village (28⁰13'09.20N, 70⁰53'36.84"E) is located 863 km from the Mashood Test Firing Range. The missile track is shown in figure 2.

7. As per our calculation, the range (ground trace) at missile burnout is 61.3 km and the altitude is 59.5 km. As the debris is much further downrange we can positively rule out failure during the thrusting phase. .
8. The newspaper Dawn also carried two pictures⁵ of missile pieces that were recovered from the scene. The pictures along with the newspaper caption are reproduced below:

debris location, it would appear that the missile was launched in a Southwesterly direction to impact in the Arabian Sea. The Arabian Sea coast is 1063 km from the Mashood Test firing range and the missile was planned to impact in the sea off the Sonmiani test range. This compares with our computed range capability⁴ of the Ghauri missile which is 953 km with a payload of 1000 kg for 135⁰ launch. The distance to the coast is within the ball-park figure of payload and vehicle parameter uncertainties.

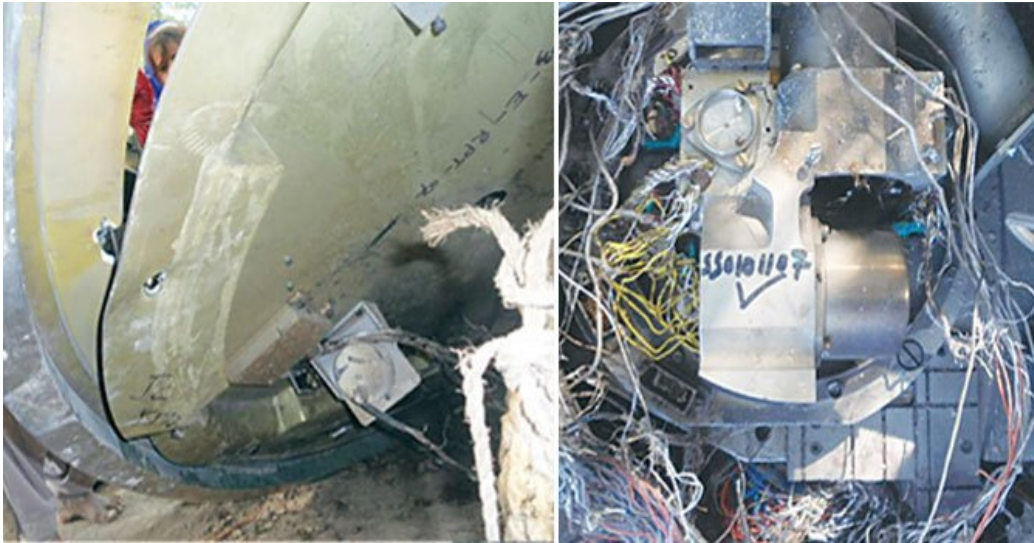
Photos show the metal pieces, now said to be parts of the Hatf-V Ghauri's motor, which fell on some villages in Sind province's Dadu district on Wednesday night.—Dawn Photo

9. The following details can be made out from the images⁶:

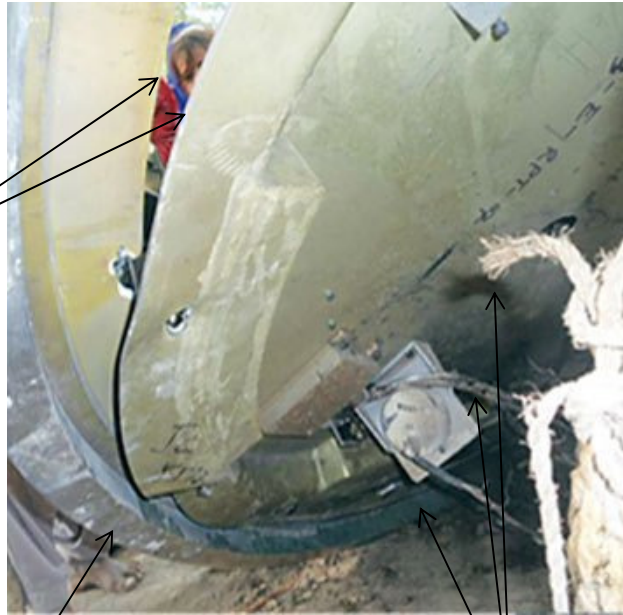
Figure 3: Bulkhead debris

Left hand image: The details are shown in figure 3.

- The centre line of the dish carries the marking '3-E-RPT-9'. It is perhaps a hardware identification number. The expansion for RPT could not be made out.
- The section is part of a bulk head structure
- The dish is severed (caused either on impact or by flexible linear shaped charge used in destruction and stage separation systems)
- Some parts of the dish are heat affected, but the overall damage signature is not due to flame cutting.

Impact or FLSC
induced separation

Bulkhead

Heat Affected Zones_

10. Flexible linear shaped charge (FLSC) induced separations tend to be clean and normally do not leave signatures of heat affected zone. The Ghauri missile will have a bulkhead at the fore-end corresponding reentry vehicle/motor joint or at the aft-end corresponding to the motor/fin shroud joint. If the reentry vehicle is separated from the main vehicle, the forward bulkhead will be separated using FLSC. **It makes sense to do this operation immediately after burnout, rather than at the fag end of the mission** (i.e. near the debris location point).

12. From the analysis presented under point 9, it can be concluded that the debris is from the aft bulkhead area of

13. As there is no reason to separate this joint from the missile, the damage is not due to FLSC but severance has occurred due to impact with the ground.

14. It is possible that some gas leakage has occurred during the thrusting phase of the motor and cause local heating and heat affected zone. This could have weakened the structure. The structure could have failed during the reentry phase due to adverse imposed structural loads.
